# Geological survey report of the Bisteutar and Jhyadi villages, Sindhupalchowk

May 20, 2015

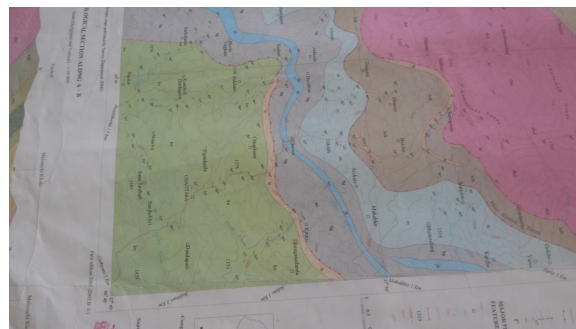
After consulting the Department of mines and geology, the geo-morphology was known and it was found that the Bhimtar area mostly contains Benighat slate i.e. thinly graded dark grey to black slate, grey phyllites with bands of Jhiku carbonates. There are also traces of low grade metamorphosed clay rich mudstone. The soil is red and is high in ferric oxides.

Figure 3: Geo-morphological map of Bhimtar area, acquired from Department of Mines and Geology, Nepal.

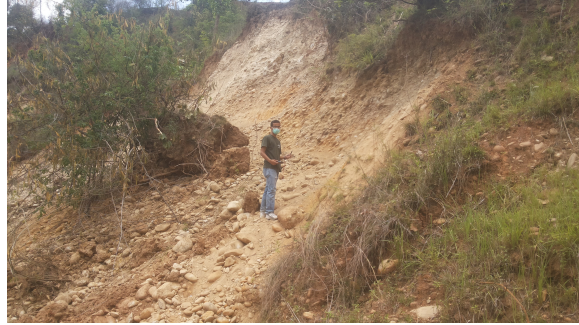
Bisteutar village lies at an elevation of 600 to 740 meters. Two points were selected within this span to study the different morphologies. The side facing the Indrawati river has alluvium deposited by the river and it has slowly been uplifted. The underlying rock has a dip of 38° and a strike of 300°. As the dip implies the slope of the underlying rocks, the loose alluvium rests on a big gradient and is easily prone to landslides. This seems to be the most plausible reason for the occurrence of dry landslide after the recent earthquakes. This face also has big cracks measuring upto 7cm in length and at least 2-3 meters in depth. The soil is resting on a loosely compacted alluvium and is very prone to erosion.

Figure 4: Landslide with a span of 73 meters and height of 95 meters in the western (Indrawati facing) side of Bisteutar village.

The road section in Bisteutar is constructed on the face containing loose alluvial deposits without reinforcements has led to the exposure of the weak underlying sediments. As the loose sediments have a very low load bearing capacity, the land above is slowly subsiding and this has been further helped by the recent earthquake which created several fractures. This face of the hill will most probably experience big landslides coming monsoon and it is recommended to either move the settlements to the side facing Jhyadi khola or some other safe place.

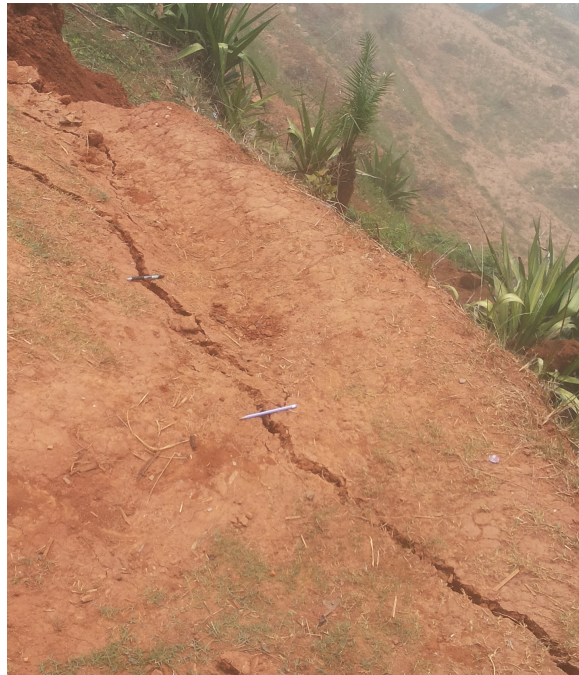
Figure 5: One of the cracks on the western face of Bisteutar village hill.

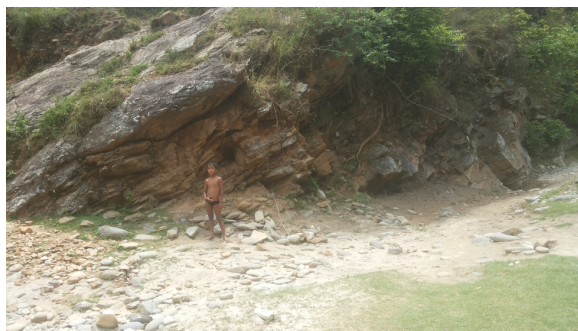
The morphology changes at the ridge of the hill and the other side facing the Jhyadi river has very little alluvium and the underlying slaty phyllite can be observed at the surface. No cracks were visible on this side of the mountain and there are no landslides. The rocks on this face at the top as

well as the bottom have the same dip and strike, so it can be assumed that there are no big faults in between.

Figure 6: The stable slaty phyllite face of the Bisteutar hill, which faces the Jhyadi river.

For habitation the side facing the Jhyadi river seems to be the safest option at least for this monsoon. As the full length of the hill was not traversed and only the cracks known to the locals were observed, the improbability of landslides occurring in this face can only be assumed with partial confidence.

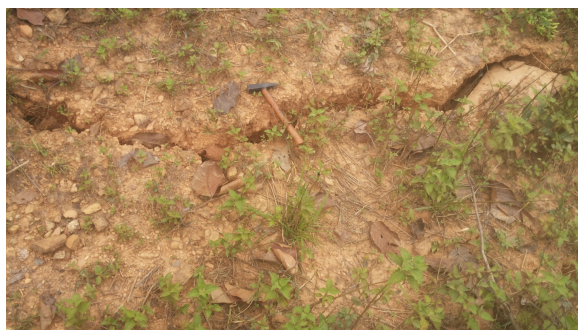
Jhyadi village also lies at the same altitude but is much closer to the mountain face. The lower part of the mountain is composed of sandstones and the upper part has slaty phyllites that are quite similar to the ones in Bisteutar village. The stones are dipping only at  $18^\circ$  so this face of the mountain was relatively safe from landslides until now. However the earthquake has created two cracks along the length of the mountain and the currently habited area falls within these cracks.

The cracks are bigger than the one in Bisteutar and were upto 10 cm in width and at least 2-3 meters in depth (we didn't have a longer probing stick). The rocks in this mountain are low to medium grade metamorphic, so they are much better than the alluvium in Bisteutar but the cracks could lead to a massive landslide in the monsoon.

Figure 7: One section of the crack that runs along the length of the Jhyadi village hill.

The inhabitants might be much safer if they are moved south from the section which contains cracks on both sides.

In Jhyadi village the situation is not as bad as the one in Bisteutar but there is also a probability of a big landslide due to the deep cracks that run along the length of the hill. As the rocks are low to medium grade metamorphic, they have considerably higher load bearing capacity in comparison to the alluvial deposits. Initial survey suggests that the people should be moved south but a thorough investigation and creation of proper drainage and gabion walls in places could greatly minimize the landslide risk. Cost benefit analysis has to be done to compare the costs of relocation to geo-technical engineering.

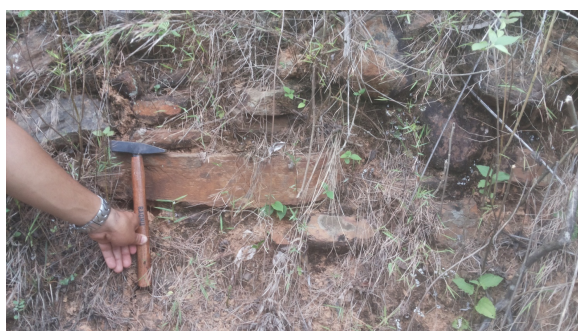
Figure 8: Underlying sandstone at the base of the Jhyadi village.
